Production R&D Development Project#: FF-LIFT-021617-A-002 Date#: 2/16/17 Company: #####

Title: Aircraft Engine Aluminum Fan Case – Bolt Hole Repair

Goal: Scale-up (from MRL4) and demonstrate (to MRL7), a weld repair addressing elongated/corroded bolt holes in aircraft engine aluminum alloy fan case flanges while meeting mechanical property requirements.

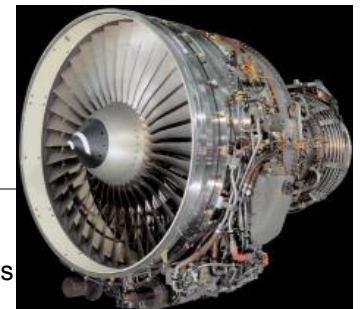
Figure 1

Aluminum alloys are widely used to make cases in the “fan/booster” section of aircraft engines – newer engines are moving to composite cases but considerable aluminum alloy cases are still in use. As an example, the CFM56-5B engine that powers the Airbus A318/A319/A320/A321 and Boeing 737 aircraft, uses an aluminum fan case. Fan cases have hundreds of bolt holes for mechanical fastening; due to galvanic action and service loads, bolt holes can get elongated or corroded. As cycles accumulate, holes have to be “plugged” and re-drilled. The company has developed a technology (to MRL4) that addresses weld-repair of elongated/corroded bolt holes. A plan to demonstrate full-scale repair and meet mechanical property requirements can deliver this technology to MRL7.
